LOS ANGELES RIVER ECOSYSTEM RESTORATION

Lauren Coe, P.E.
Hydraulic Engineer

November 02, 2022

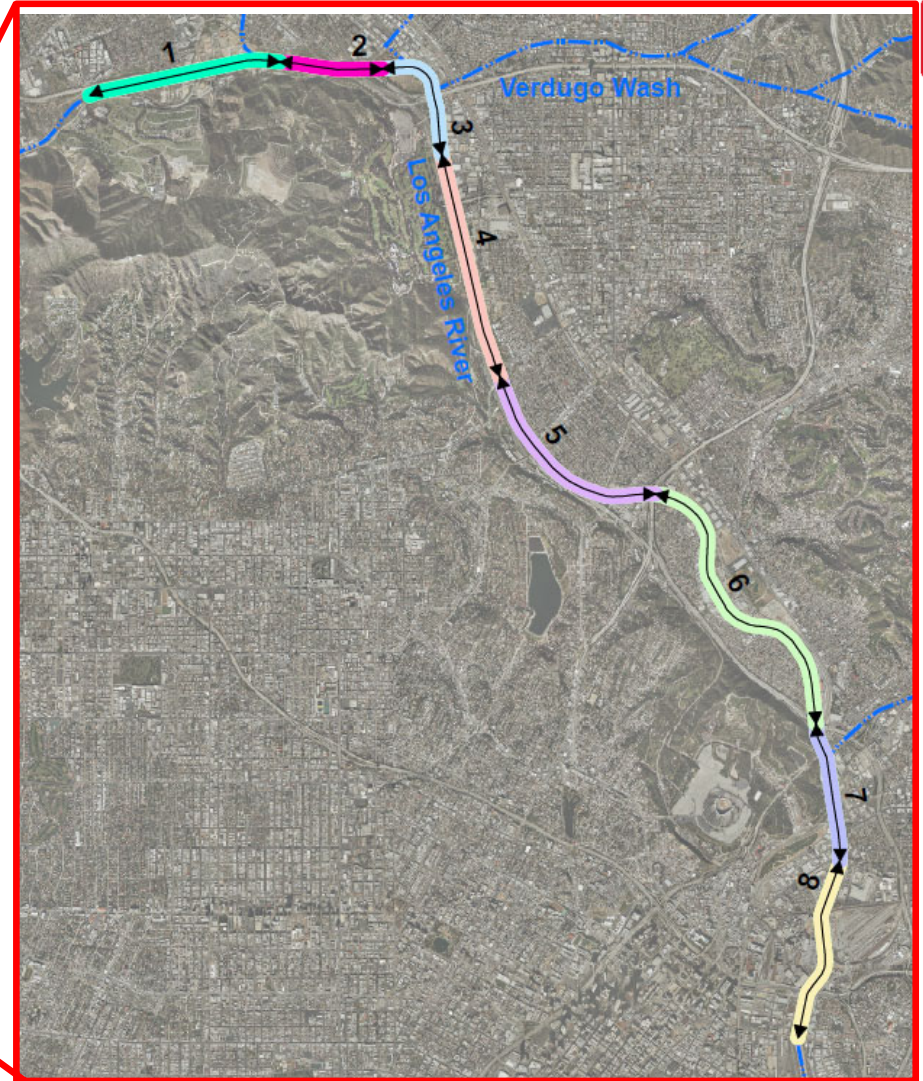
8 Reaches

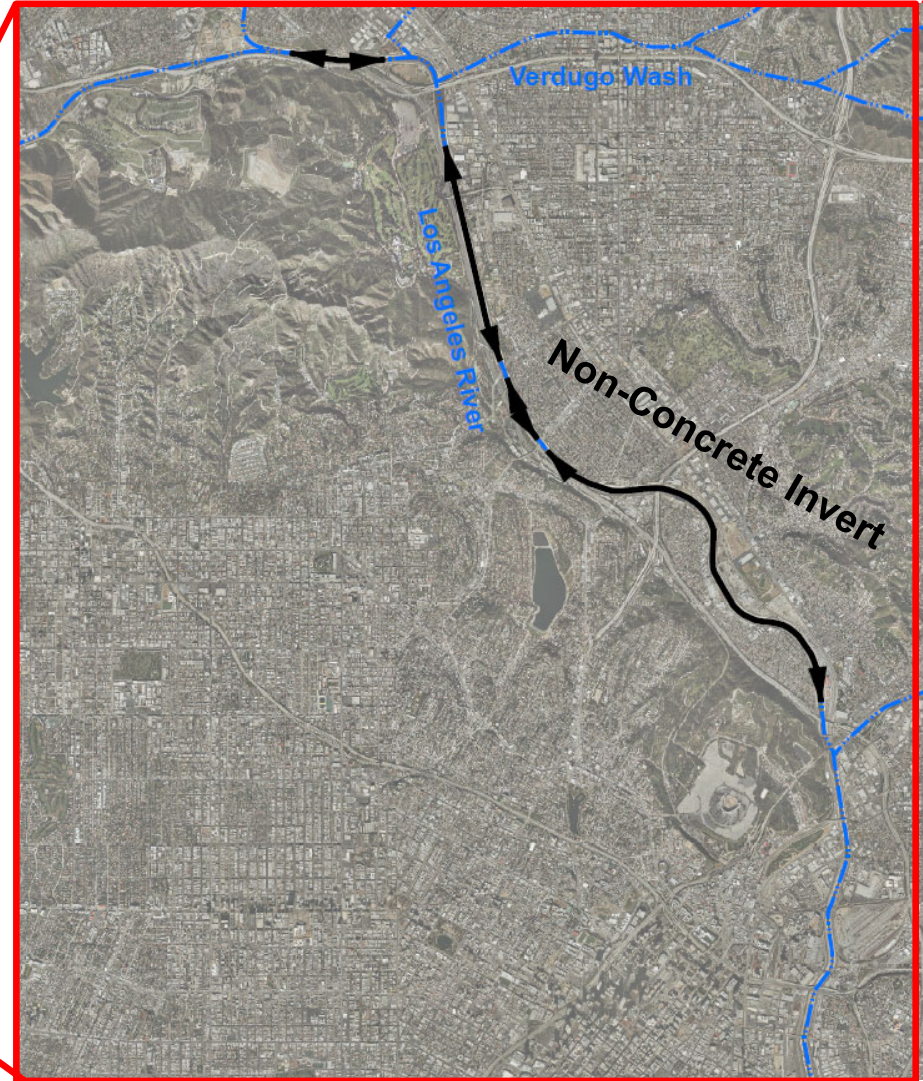
Primarily, channel with concrete invert and concrete side slopes

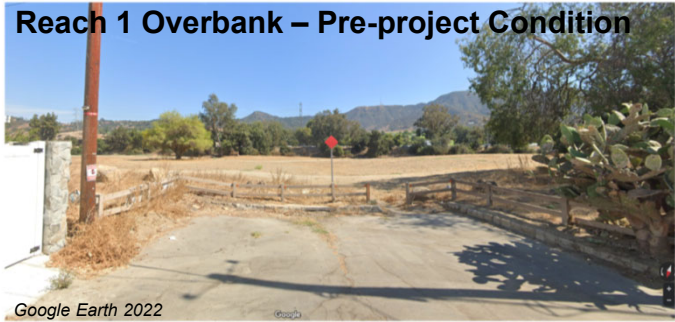
Reach 1 Overbank – Pre-project Condition

Restoration of riparian habitat corridors outside of the channel

No channel modification

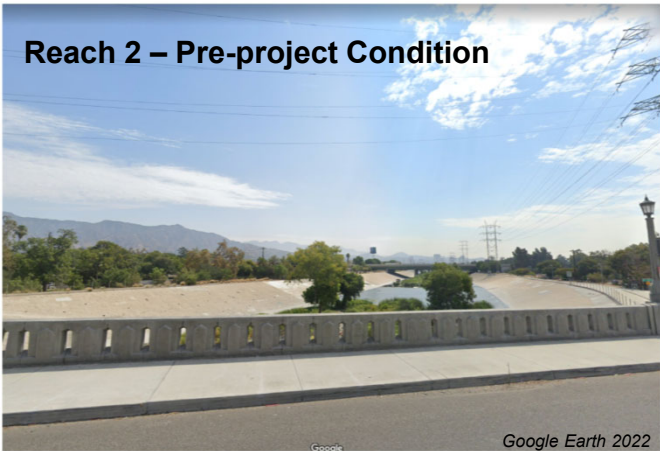
Reach 2 – Pre-project Condition

Restoration of riparian habitat corridors outside of the channel

Change channel configuration from trapezoidal to rectangular

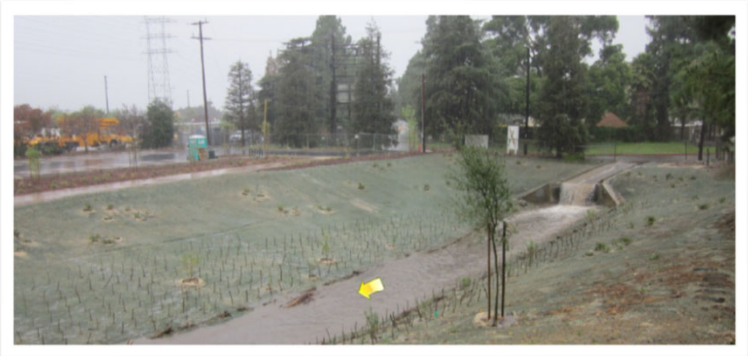
Atwater Park 2011. Daylighted Storm Drain

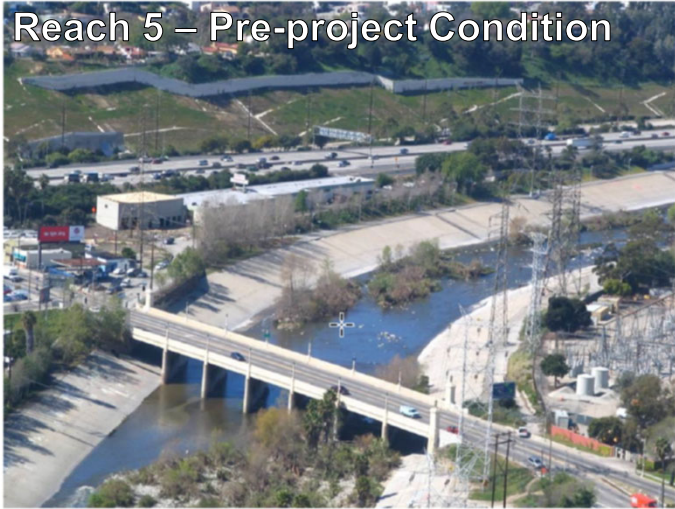
Reach 5 – Pre-project Condition

Restoration of riparian habitat corridors outside of the channel

Daylight storm drains

Terraced banks

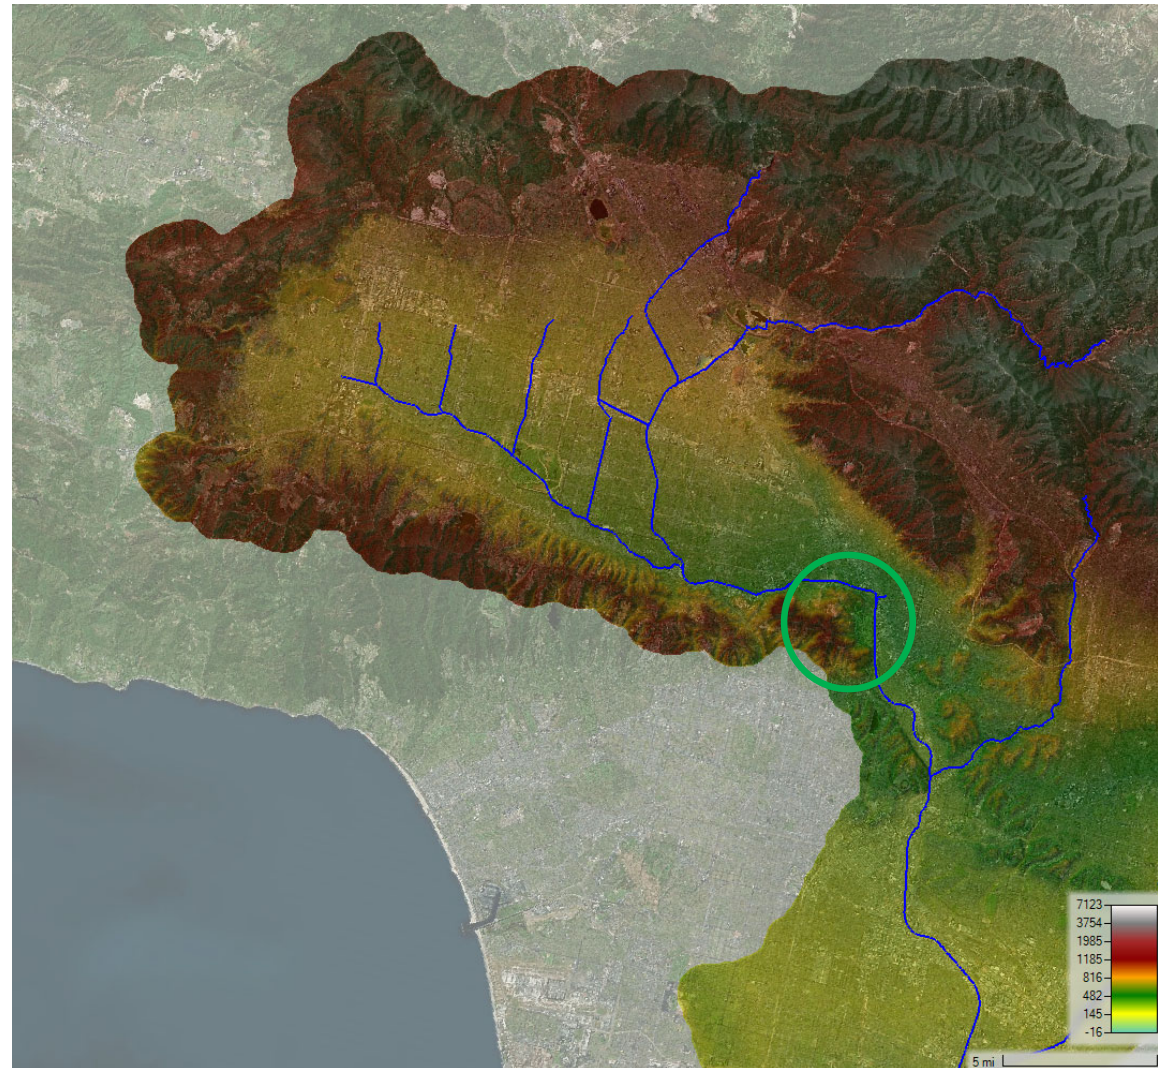
- Mediterranean with average annual precipitation = 17.5 inches
- Upper LAR Watershed = ~600 square miles (~1,550 square km)
- Performed model calibration in HEC-HMS
- 6 reservoirs: HEC-ResSim for complex reservoir operations
- Bulletin 17C Methodology for Flood Frequency Analysis

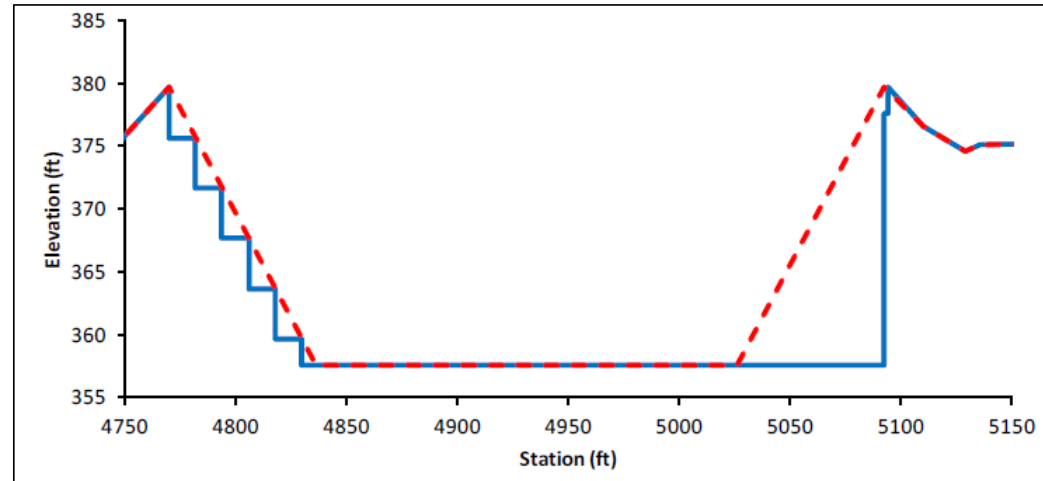
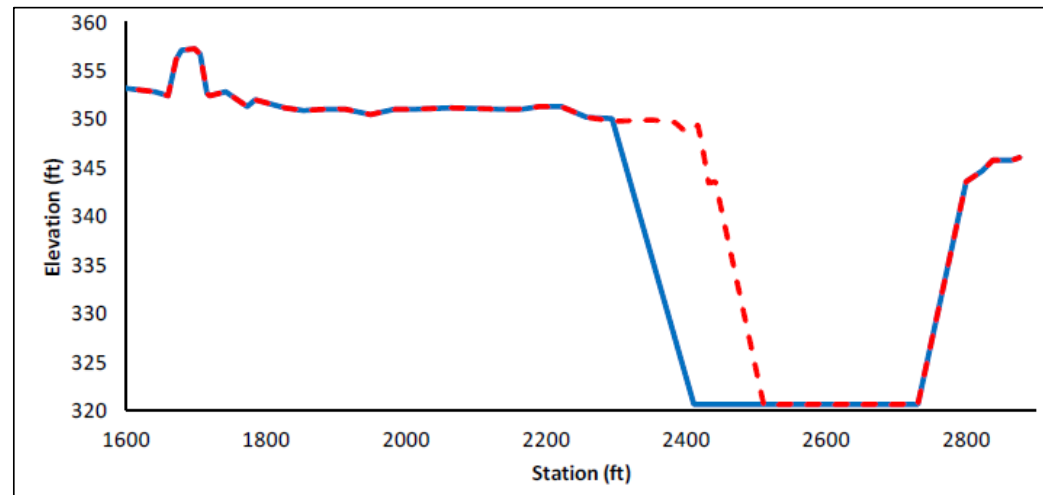
- Baseline hydraulic modeling will establish current conditions
- 2-Dimensional ADH model for 11-mile reach
- 3-Dimensional modeling at select confluences
- Physical model results used for numerical model validation

- - - Existing

— Project Channel Modifications
