Case Study: Predicted Sediment Transport for Operations at Nolichucky Dam

Martin Teal, Filippo Bressan, WEST Consultants, Inc.
Curt Jawdy, Tennessee Valley Authority

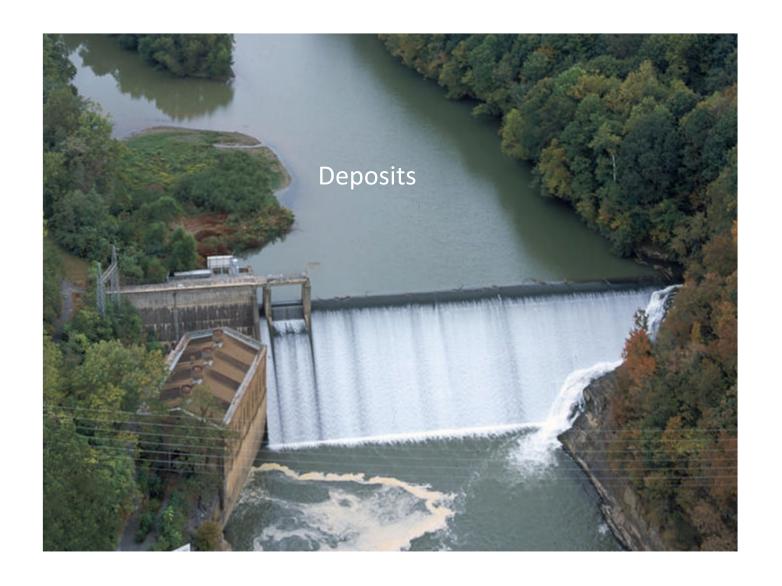
- Sediment transport modeling to examine mobilization and concentrations when gate removed:
 - Maximum concentrations and duration?
 - Predicted concentrations versus those at natural high flows under existing conditions?
 - Can avoid dredging?
