GIVING THE RIVER BACK TO ITS VALLEY:
Restoring to 'Stage 0' on the South Fork McKenzie River, Oregon, USA

Kate Meyer, Fisheries Biologist/Project Co-Lead
US Forest Service, Willamette National Forest
Australian Water School - May 2, 2023

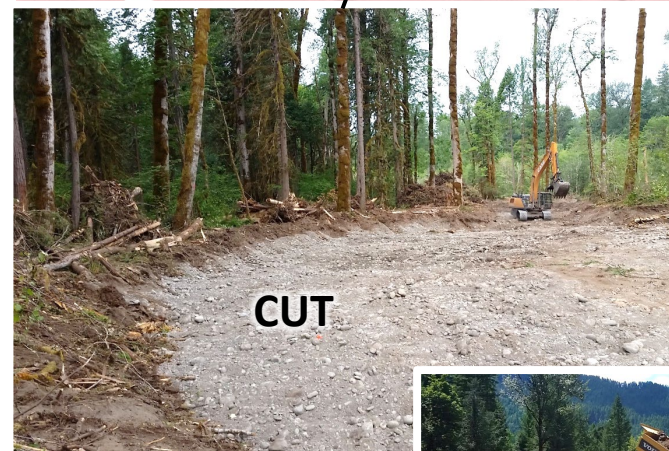
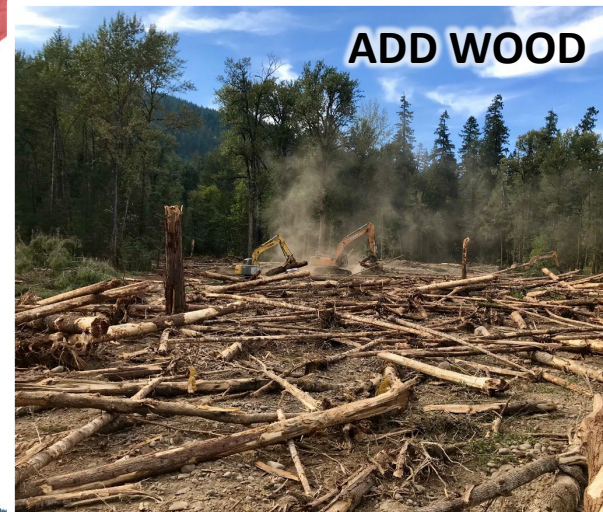
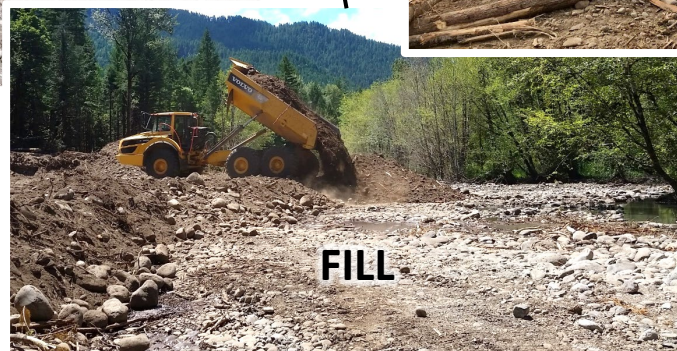
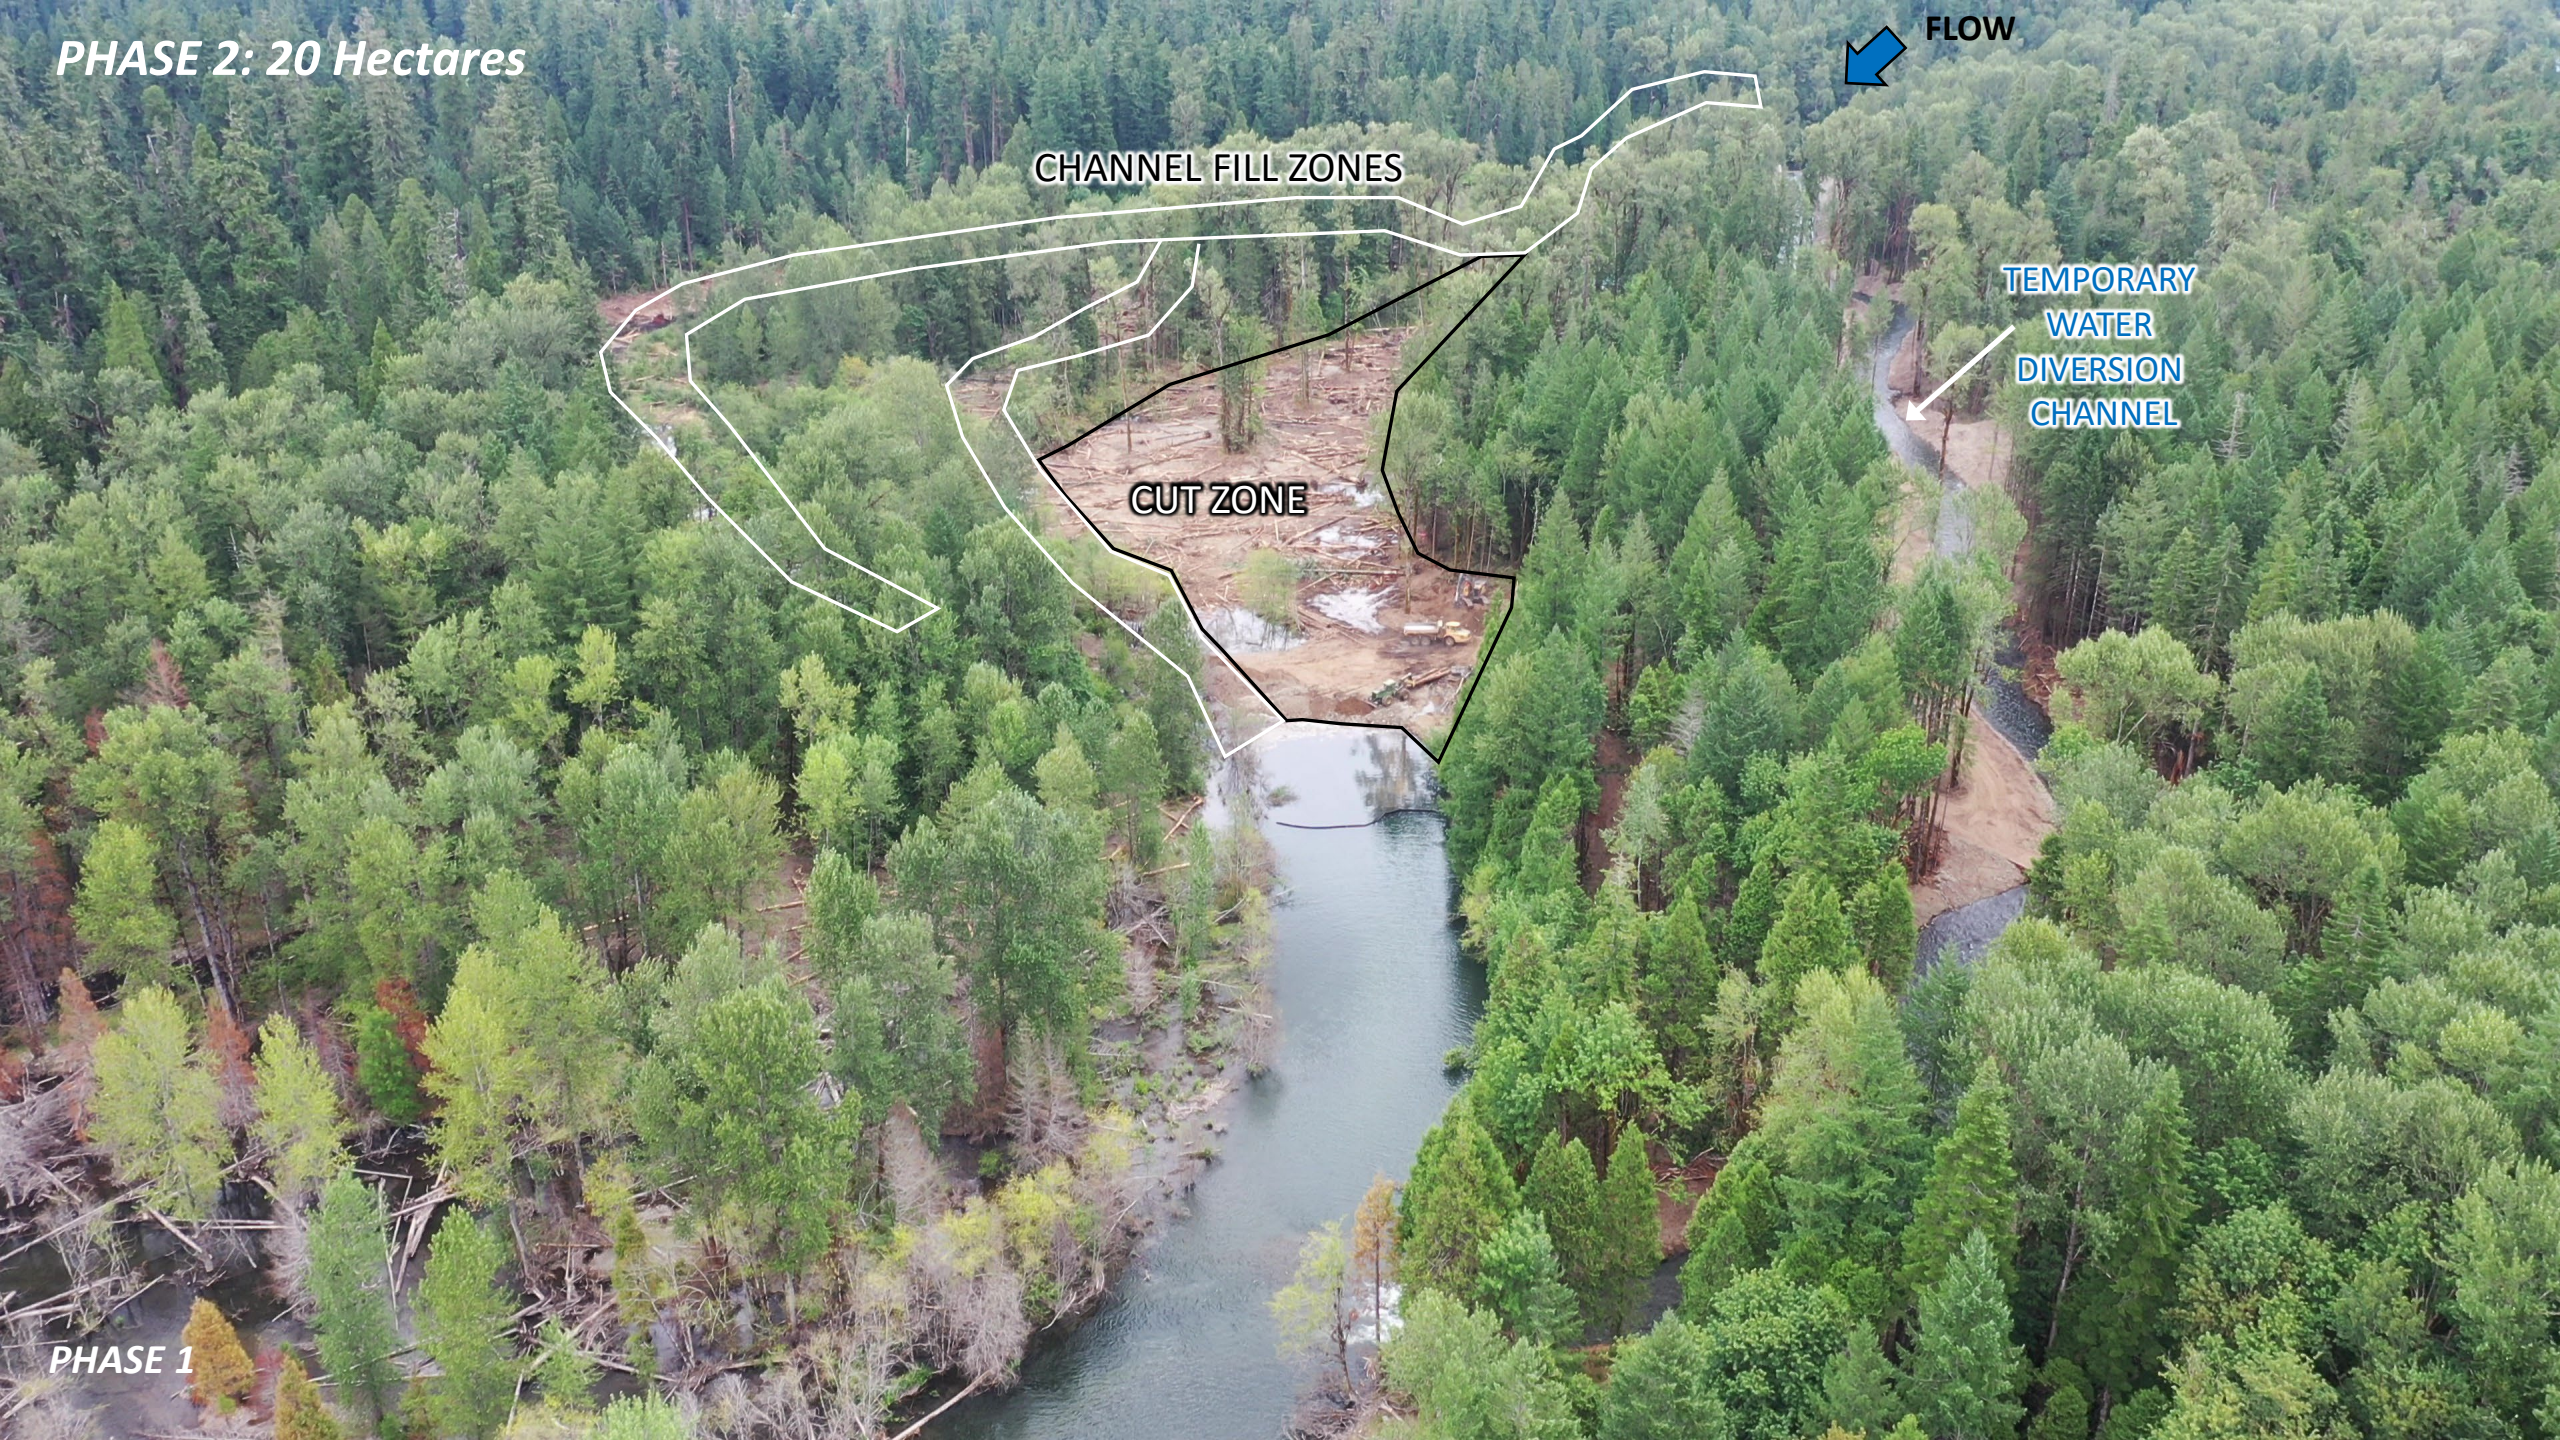
Design

PHASE 2: 20 Hectares

FLOW

CHANNEL FILL ZONES

**TEMPORARY
WATER
DIVERSION
CHANNEL**

CUT ZONE

PHASE 1

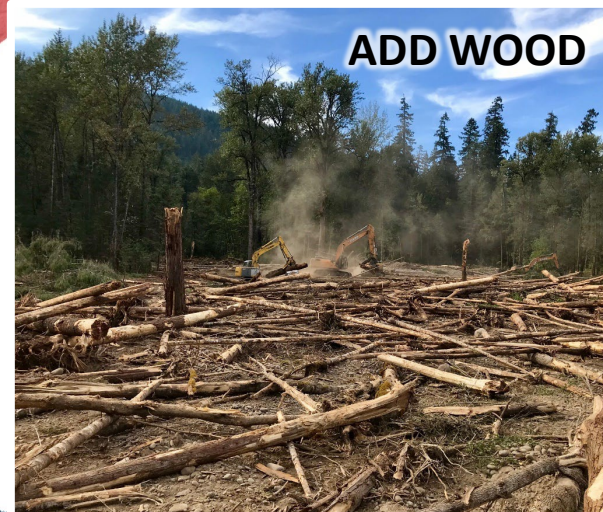
ADD WOOD

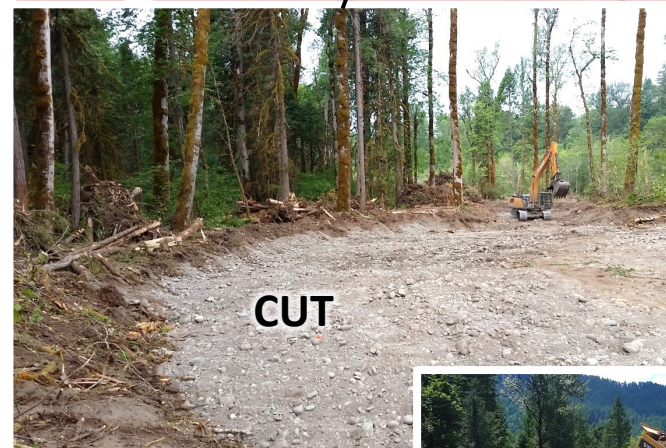
CUT

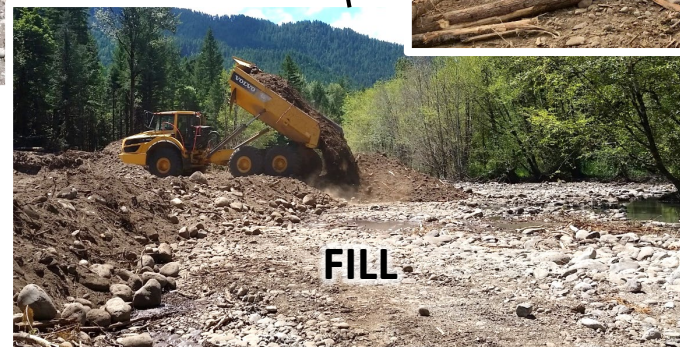
FILL

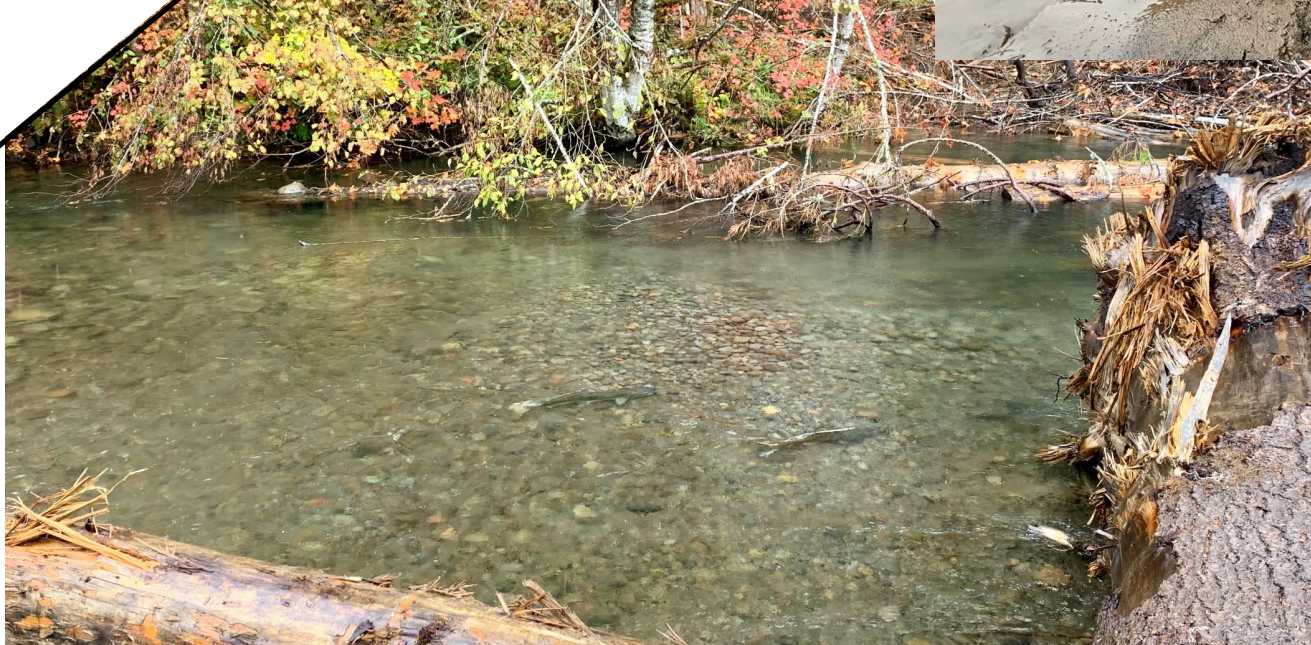
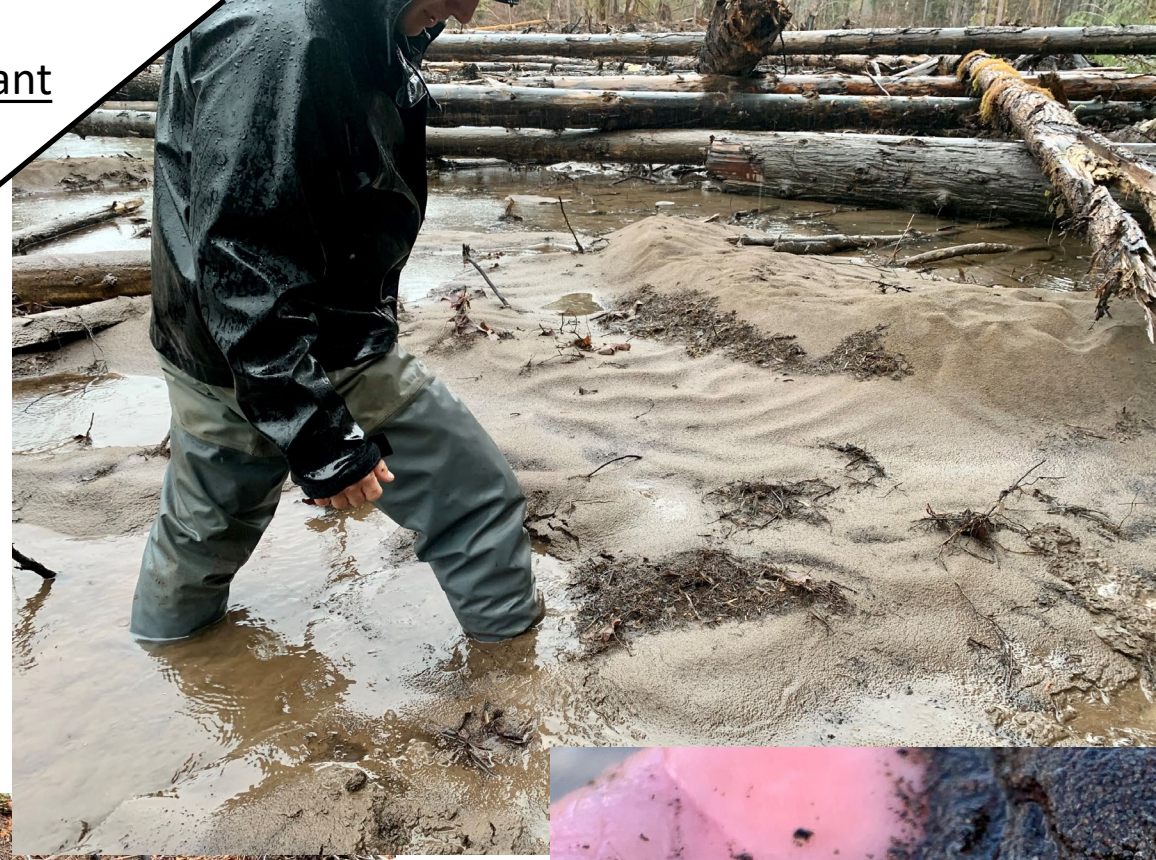
Pre-Project

Substrate: Shift from cobble/boulder dominant to gravel/fines dominant

Post-Project

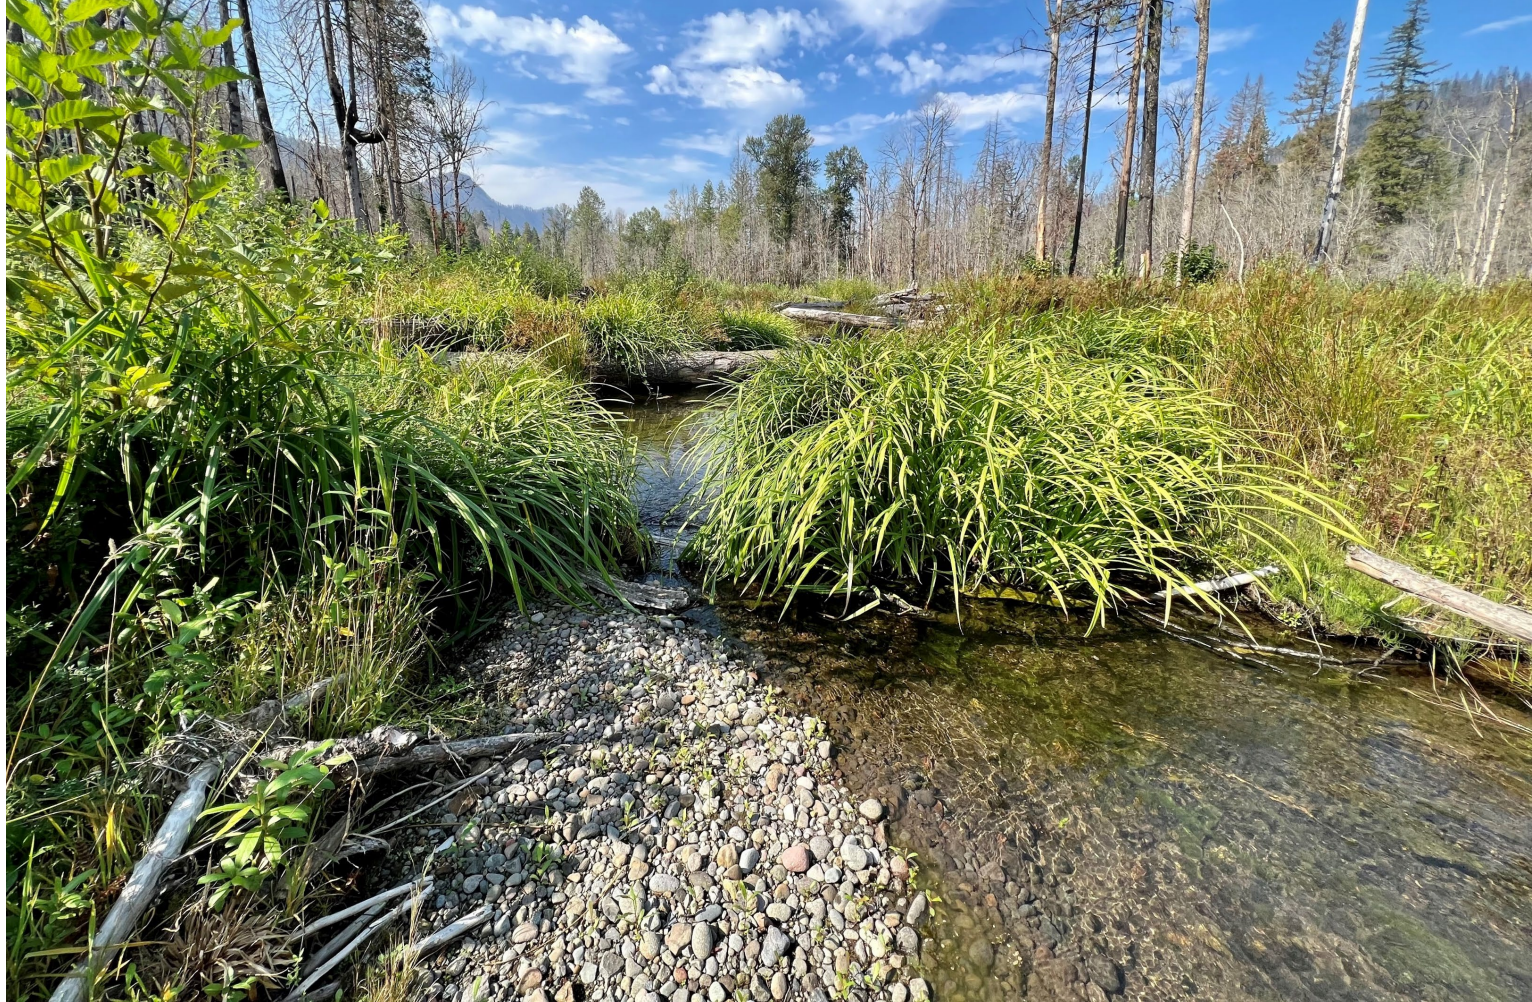
Water Temperatures:

- Warmer within the first 2 years (should cool as veg/shade reestablishes)
- High degree of spatial and temporal variability in thermal regimes (warmer and cooler)
- Large patches of cold water are connected or in close proximity

Macroinvertebrate Density, Biomass, and Diversity

- 1 year post-restoration = within the range of pre-restoration
- 2–3 years post-restoration = higher than pre-restoration

Macroinvertebrate Production

- 1 year post-restoration = lower than unrestored reaches on a per-square meter basis, but 3 times more production when scaled to wetted area

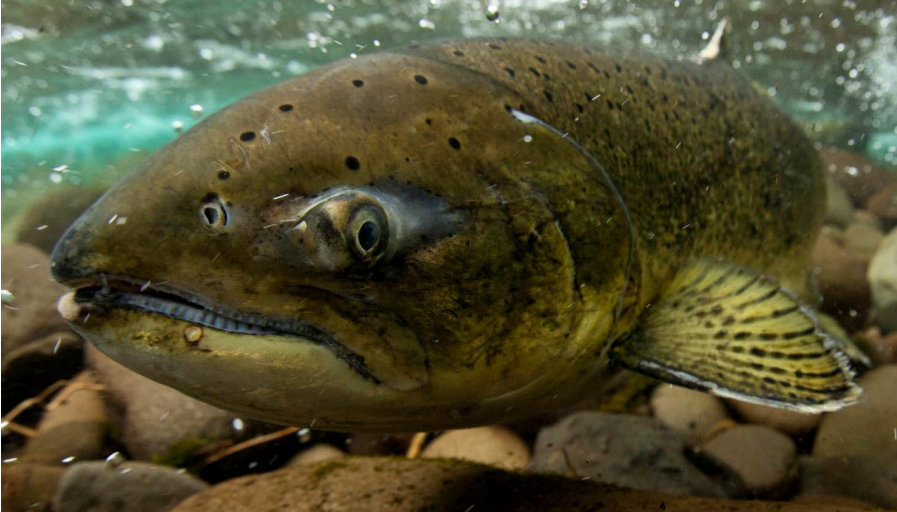
Chinook Salmon Spawning within the Project Area (2002-2022)

***10-20% of total sub-basin redds are found in South Fork project area (only 1.5% of area surveyed)**

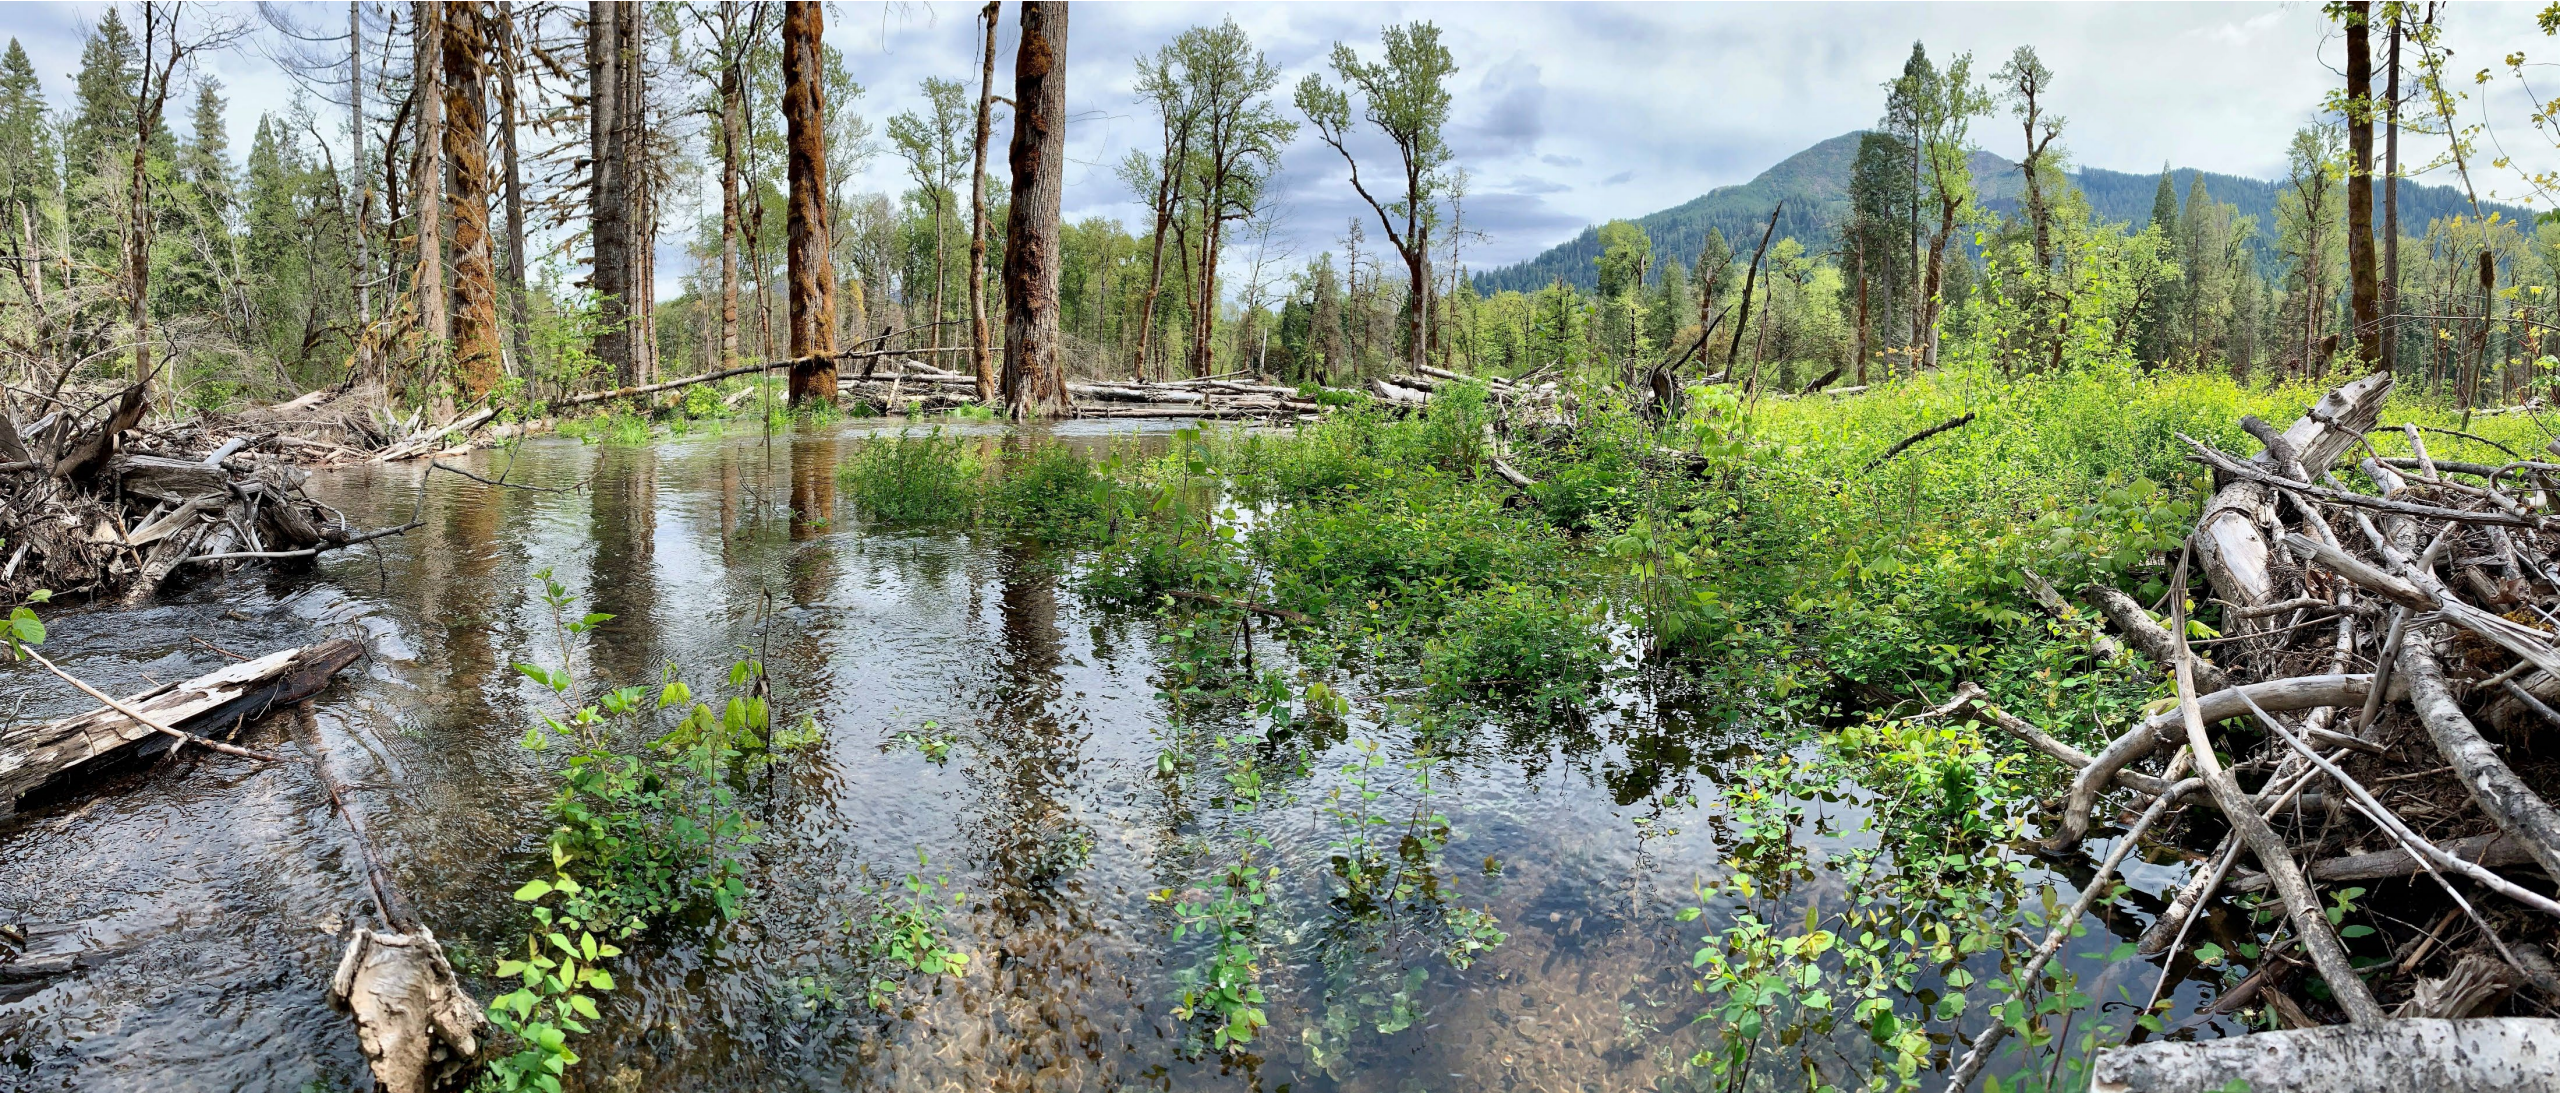
Increased Flood Resilience: Peak Flow February 2020 (~3,000cfs/85cms)

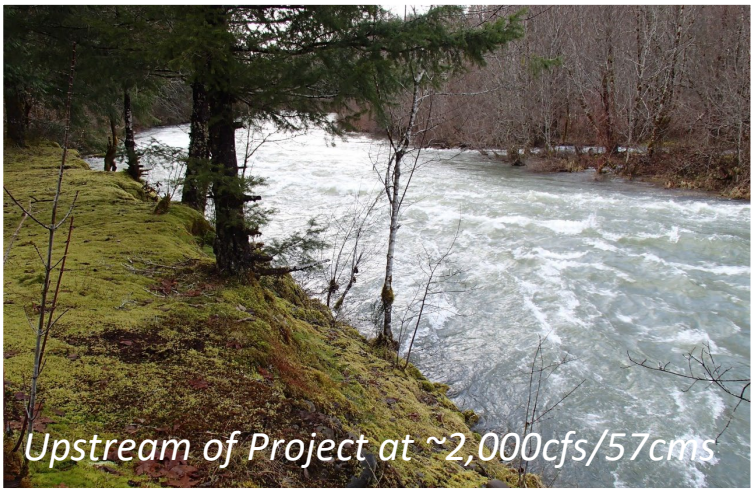
Upstream of Project at ~2,000cfs/57cms
